Learning from Earthquakes

The M_w 6.9 Sikkim-Nepal Border Earthquake of September 18, 2011

This report is edited by C.V.R. Murty and Alpa Sheth.

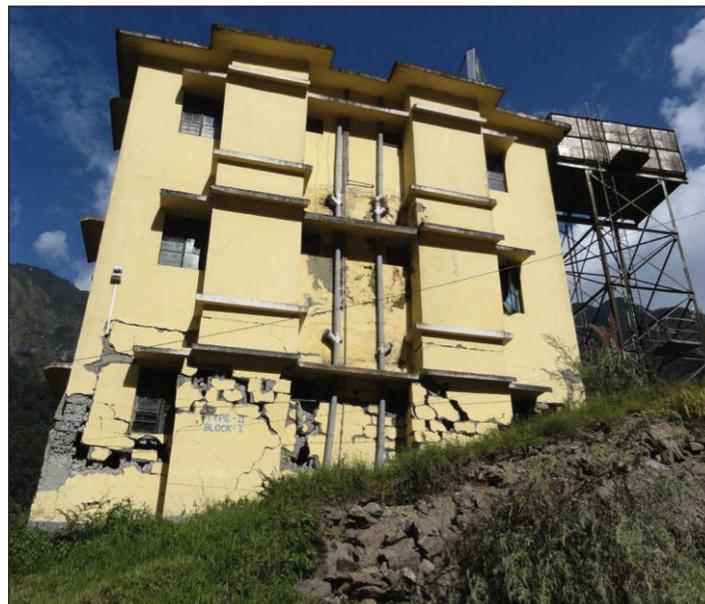
In general, the maximum intensity of ground shaking in the entire affected area was VI+ on the MSK scale, but some pockets had higher shaking owing to site-specific amplification of ground motion on a hillock, e.g., at the ITBP quarters at Pegong in Chungthang (Figure 4). Falling rocks caused significant damage to buildings and hydropower tunnel mouths in the town of Chungthang.

Figure 4. Classic damage in lower stories of RC frame building with large block masonry infill panels at ITBP quarters at Chungthang (photo: Arvind Jaiswal).

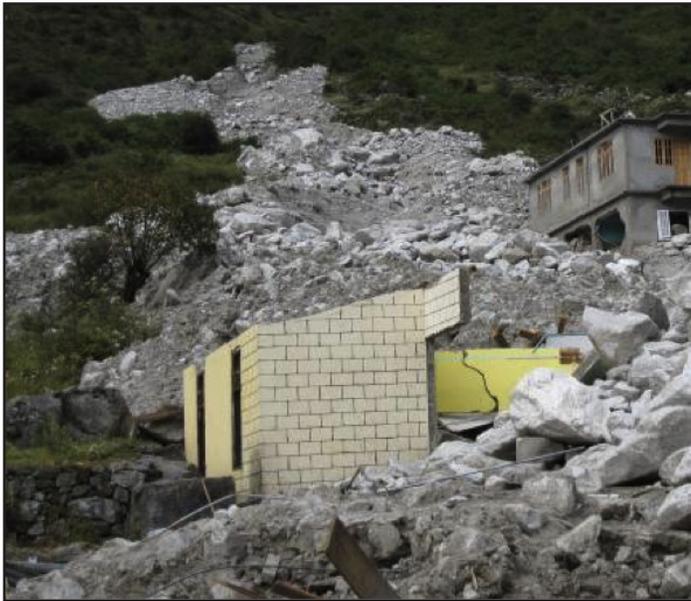
Figure 5. Damage to buildings due to rock slide at Lachung (photo: DC Rai).

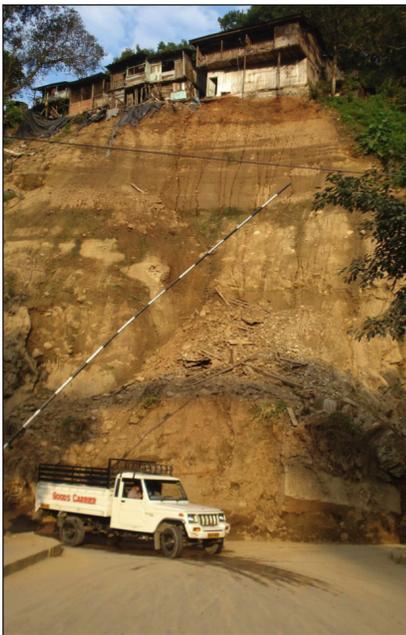
Figure 7. Landslide at the mouth of the cable-stayed bridge across the Rangit River at Jorethang-Nayabazaar in West Sikkim district (photo: C.V.R. Murty).

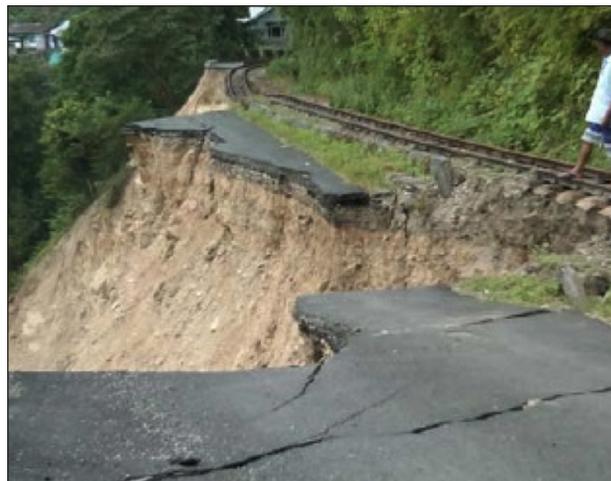
Some incidents of reactivation of older landslides were reported, for example, the Teendharia (Figure 8) and Balason landslides of the Darjeeling district and the Health Secretariat landslide in Gangtok. The

reactivation in some cases was not co-seismic, but developed over several days after the earthquake because of heavy rainfall in area. On-the-ground inspection revealed signs of continual distress that indicated the post-earthquake landslides were inducements of already ongoing slow mass movements. Enquiry with the locals in Tukdah-Rangolikhola also corroborated the landslide to be episodic, with a large event taking place several decades back.

Figure 8. Scouring of the permanent way underneath of the heritage railway line at the Teendharia landslide along NH 55 between Siliguri and Darjeeling (photo: Debasis Roy).

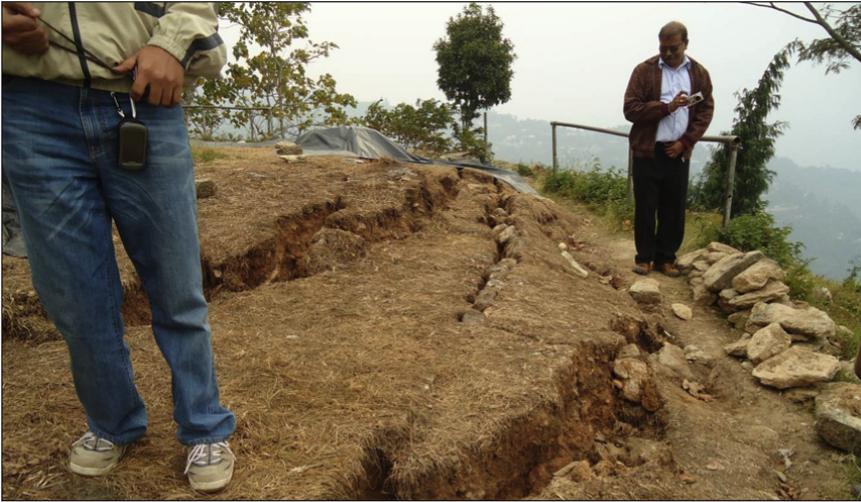
Figure 9. Lateral spreading of the soft soil hillock on which is located the Leprosy Unit of the Sub-Divisional Hospital of Kalimpong (photo: C.V.R. Murty).

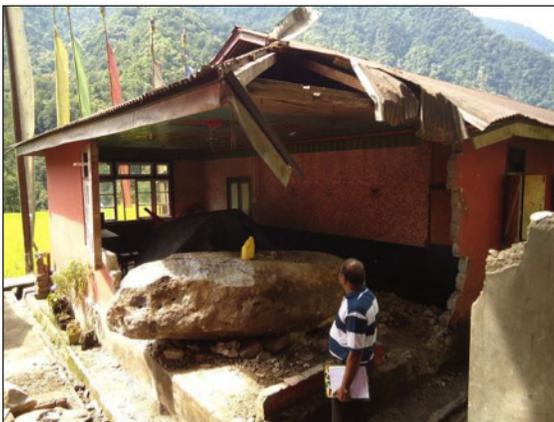
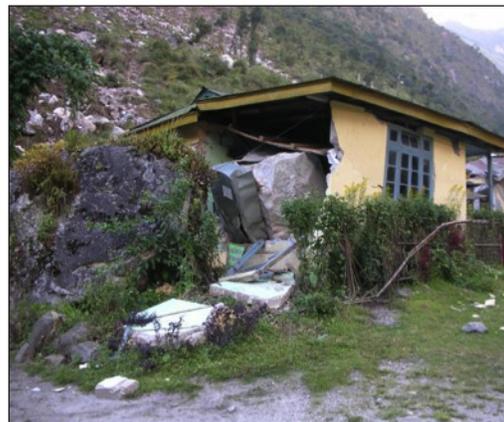
Figure 10. Damage to houses due to rolling boulder at Lingzya and Chungthang (photos: Arun Menon and Rupen Goswami).

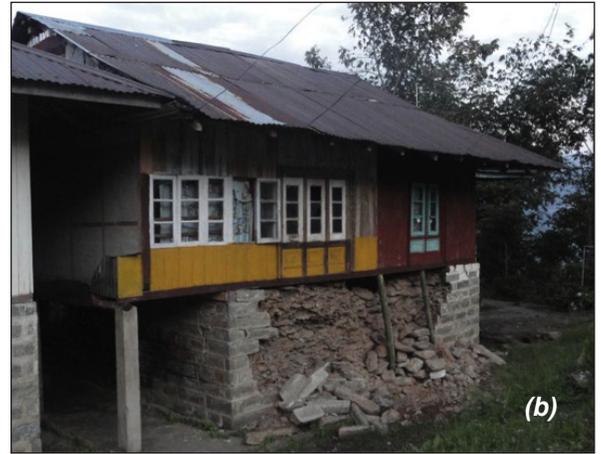
Figure 12. ▲ (a) Typical ekra house at Gangtok (photo: Alpa Sheth); ► (b) Typical house with wooden planks (Shee Khim) with damaged rubble masonry plinth (photo: AR Vijayanarayanan).

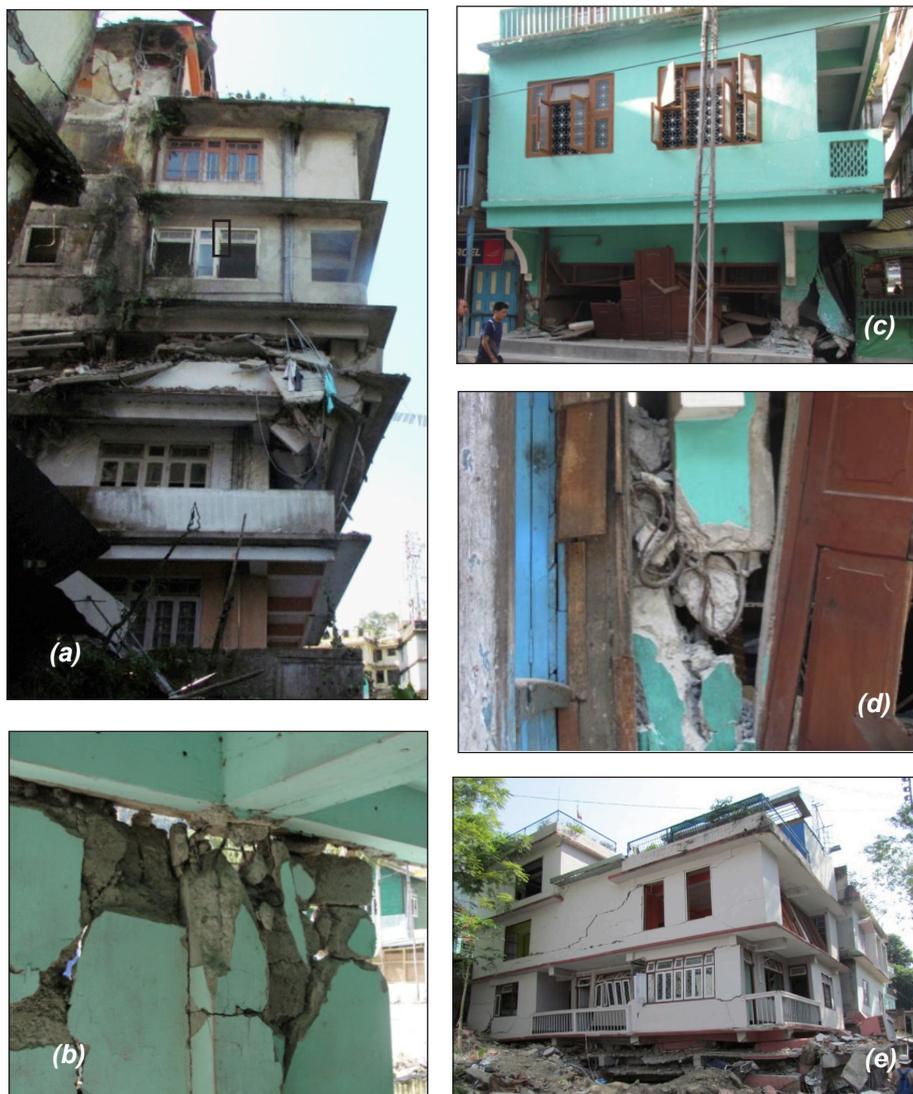
city. Buildings that had a sudden change in the stiffness pattern of the infill panel walls suffered significant damage or collapse (Figures 13a and 13b). Buildings experienced torsion and collapsed when distribution of stiffness was poor in plan (Figure 13c). Buildings with large appendages (such as Telecom towers) also behaved poorly. A four-story RC building at Dikchu bazaar (Figure 13d) constructed about 10 years ago was constructed on slope over a RC retaining wall and the slope started failing after the main shock. This resulted in severe tilting of the building along the slope, which prompted occupants to vacate the building before it collapsed completely during an aftershock two days later. Another two-story RC building constructed on slope and located near the Dikchu dam site suffered partial collapse; however, it had not been used for residential purposes and therefore losses were minimal. Also, three stories of a residential house pancaked in the town of Naya Bazaar (Figure 13e).

Figure 13. (a) Pancaked nine-story Dzongpo House building in Gangtok; three intermediate stories collapsed owing to sudden change in lateral stiffness (photo: Alpa Sheth); (b) damage to storage facility building in Chungthang (photo: Ajay Chourasia); (c) and (d) collapsed three-story RC frame building at Singtam (photo: Alpa Sheth); (e) pancaking of three stories of RC frame residential building at Naya Bazaar (photo: Alpa Sheth), and (f) collapsed four-story house at Dikchu (photo: Hemant B. Kaushik).

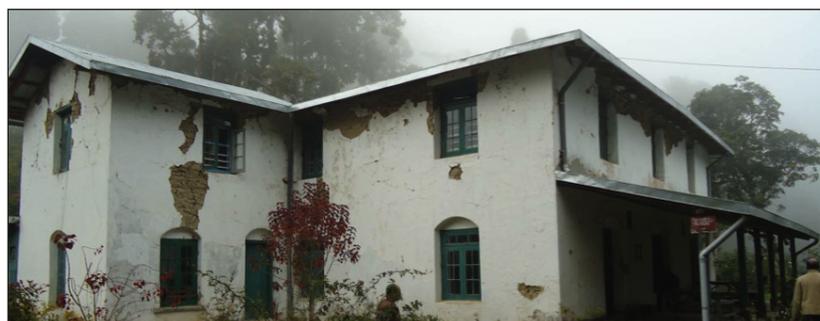
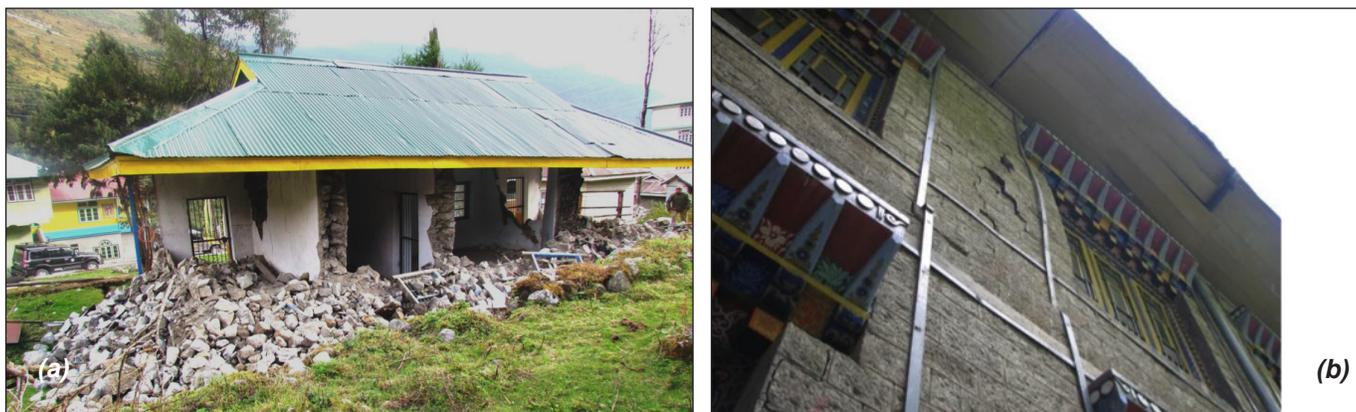
After it was damaged in the 1988 Bihar Nepal quake, the Archive Building in Gangtok was retrofitted using steel flats all around in the form of bands around window openings. The two-story building performed extremely well during the 2006 earthquake, but significant damage was observed in the lower stories after the recent event (Figure 15a and b).

Figure 15. (a) Damaged masonry building of the police check post at Lachung (photo: Alpa Sheth); (b) damage to heritage building in Gangtok (photo: Hemant B. Kaushik).

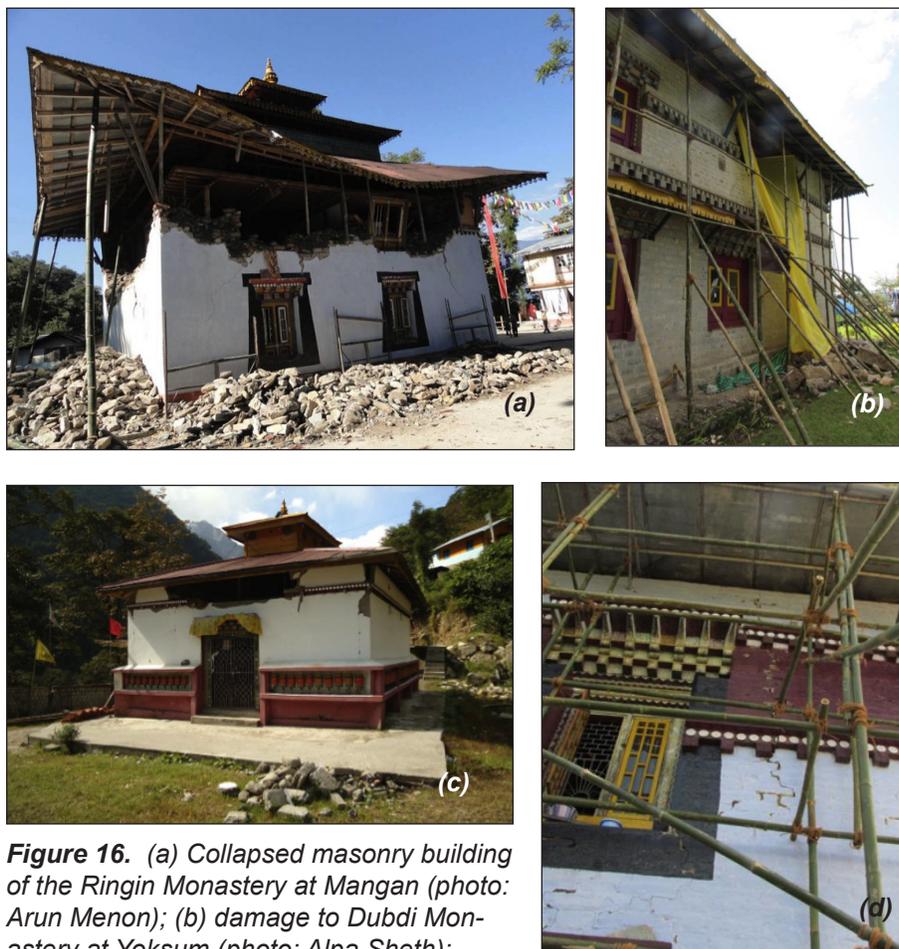
most recent quake. Extensive damage was observed in these monasteries, with partial to near total collapse in several structures. Typical damage included out-of-plane bulging or collapse of random rubble masonry walls; sliding of timber roofs relative to the masonry walls; out-of-plane collapse of orthogonal corners of perimeter RRM masonry walls; and shear failure of interior RC columns (Figures 16a, b, c, d). Almost two months after the earthquake, no initiatives were yet underway to study the genesis of the damage or undertake seismic retrofit.

Figure 16. (a) Collapsed masonry building of the Ringin Monastery at Mangan (photo: Arun Menon); (b) damage to Dubdi Monastery at Yoksum (photo: Alpa Sheth); (c) damage to Chungthang Monastery at Chungthang (photo: C.V.R. Murty); (d) damage to Pemayangtse Monastery in Pelling (photo: Alpa Sheth).

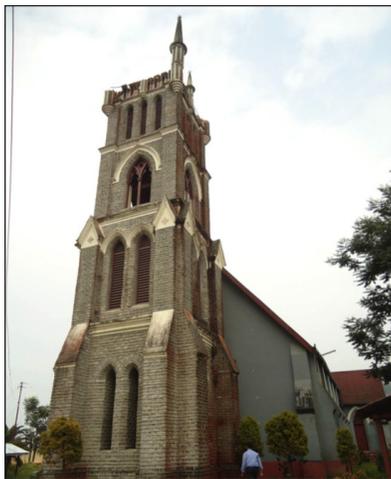
At least two colonial chapels were severely damaged during the event. The chapel designs had their roots in Scotland and England and no modifications were made on them to reflect the seismicity of the Himalayan region. At the MacFarland Memorial Church in Kalimpong the URM spires atop its bell tower are near collapse (Figure 17), and there is in-plane shear damage to the walls and gothic arches. The chapel on the estate of Dr. Graham's Homes had been damaged during the 2006 event, and was retrofitted locally by tying the arches with a 20mm diameter steel rod with end plates. During the recent quake, there was a much larger in-plane shear failure crack on the front wall and significant damage to the perpendicular wall and internal arches (Figure 18).

Figure 17. Collapse of unreinforced masonry spires of the bell tower of the MacFarland Memorial Chapel in Kalimpong (photo: C.V.R. Murty).

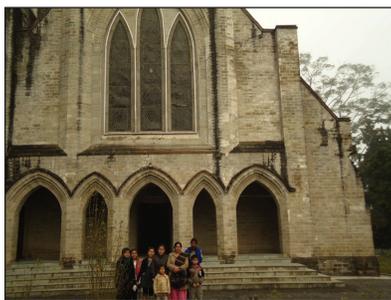
Figure 18. Crack initiating from the central arch and propagating towards the right top through the central glass windows at the chapel in Dr. Graham's Homes estate in Kalimpong (photo: C.V.R. Murty).

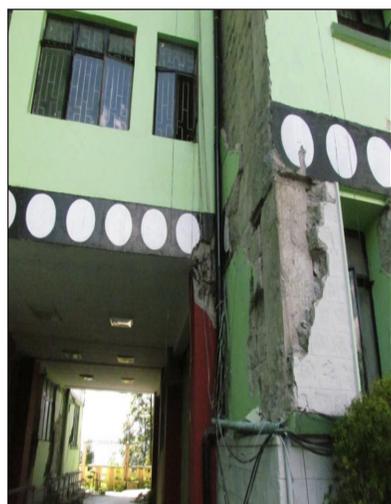
Many government buildings were affected, even recently built, engineered RC structures. At the Secretariat Building in Gangtok, made of RC frame with unreinforced masonry infills of cement-block units, there was extensive damage to the infills of lower stories, pounding damage in the false ceiling at construction joints, and delamination of tiles along the corridor in upper stories (Figure 19). The annex portion of the building had damage in two RC columns at the expansion joint. The entire building was abandoned along with the annex portion. The Legislative Assembly Building in Gangtok, a RC frame building with URM infills, was retrofitted in 2010, but it had significant damage to internal and external infill walls, in addition to increased subsidence at the plinth level. Police check-posts and offices made of RC with URM infill walls were damaged to the extent of being rendered unsafe for operations. Also, the Police Headquarters Build-

Figure 19. Structural damage at expansion joint of Secretariat building in Gangtok (photo: Alpa Sheth).

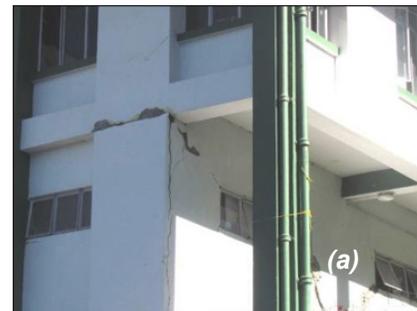
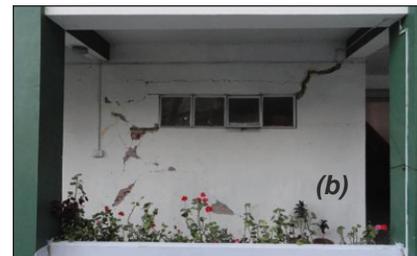
ing in Gangtok suffered serious damage to its RC elements and URM masonry infills (Figure 20). At the Governor's estate in Darjeeling all dressed stone masonry buildings (1-3 stories tall) had separation at wall junctions and in-plane shear failure.

Figure 20. (a) and (b) Damage to three-story RC frame building with masonry infills of the police headquarters in Gangtok (photos: Alpa Sheth and AR Vijayanarayanan).

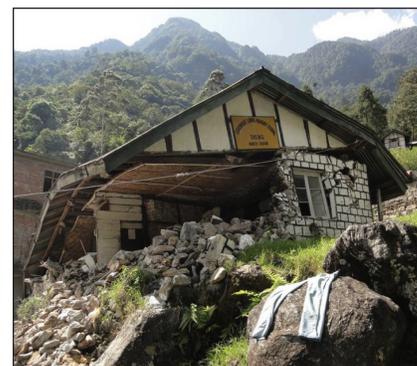
Figure 21. Collapse of masonry building of the primary school at Theng (photo: Arvind Jaiswal).

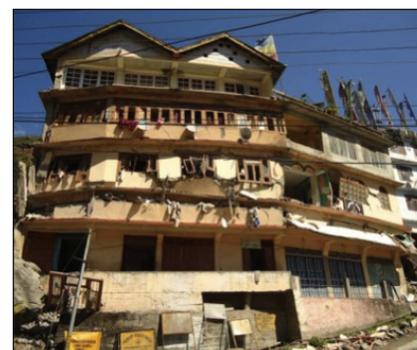
Figure 22. Pancaking of one intermediate story in five-story RC frame building of the Moonlight School at Chungthang (photo: Arun Menon).

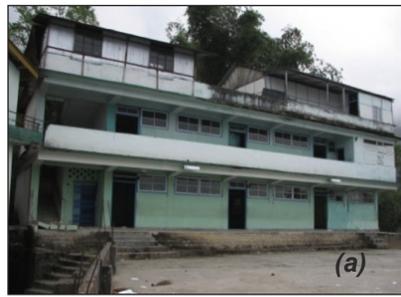
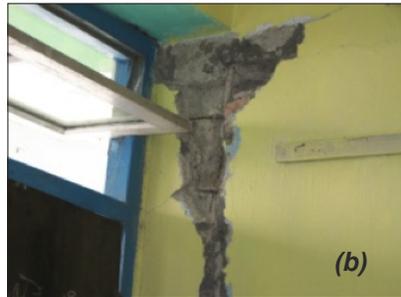
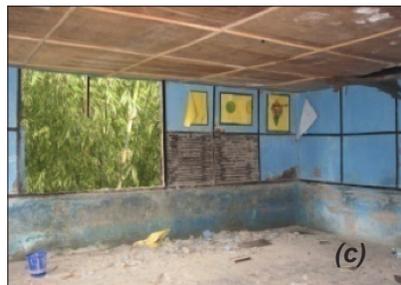
Some of the school buildings had suffered damage in the 2006 earthquake, but were not retrofitted. For instance, the old building of Government Secondary School at Sichey is a 3-story RC building with brick masonry infill walls constructed in 1969. Minor damage was observed in this building during the 2006 earthquake; however, it suffered extensive damage during the recent quake and the entire school building had to be abandoned. The adjacent new building of similar construction suffered extensive cracking in floors due to ground movement, cracks along the staircases, and separation of brick masonry infill panel along the edges of beam and columns (Figure 23a). RC columns in both buildings were damaged, especially those located near the door openings and in the corridor (Figure 23b). The walls of Ekra rooms in the terrace of the new building also suffered damage in the form of out-of-plane collapse and spalling of cement plaster (Figure 23c).

Figure 23. Damage to government secondary school at Sichey: (a) annex building, (b) RC columns, and (c) Ekra walls on top floor (photos: Hemant B. Kaushik and Kaustabh Dasgupta).

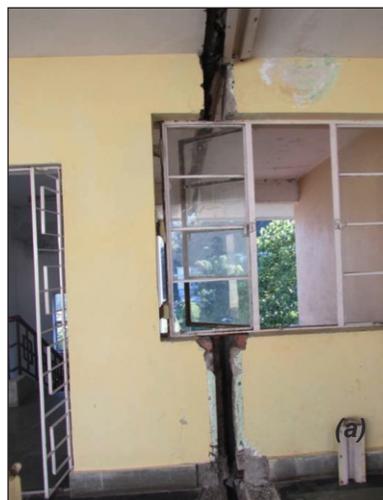
type to unreinforced masonry structures, and recently to reinforced concrete. In most of these structures, pounding damage was noticed at construction joints (Figure 24a); frame-infill separation, cracking of plaster and diagonal cracking of infill walls were observed in RC frame buildings (Figure 24b), as was damage due to incorrectly detailed seismic joints.

Figure 24. (a) Pounding damage at expansion joints in five-story RC frame building of SMIMS boys’ hostel, Tadong (photo: Alpa Sheth); (b) frame infill separation in Primary Health Centre at Passingdang (photo: Rupen Goswami).

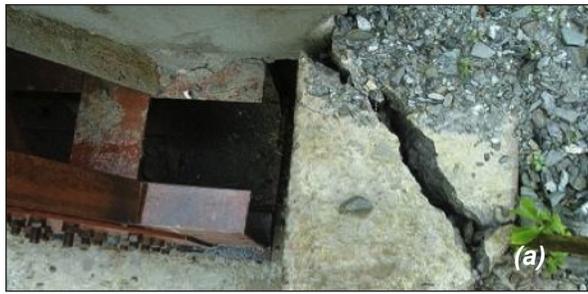
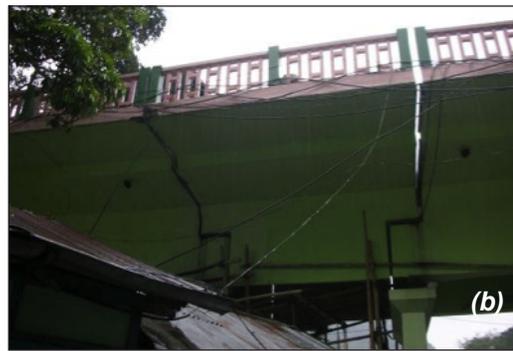
Figure 25. ▲ (a) Damaged abutment of bridge at Ralom Phamtam [photo: Government of Sikkim] and ► (b) pounding and residual displacement in deck in Jawaharlal Nehru Bridge at Melli (photo: Rupen Goswami).

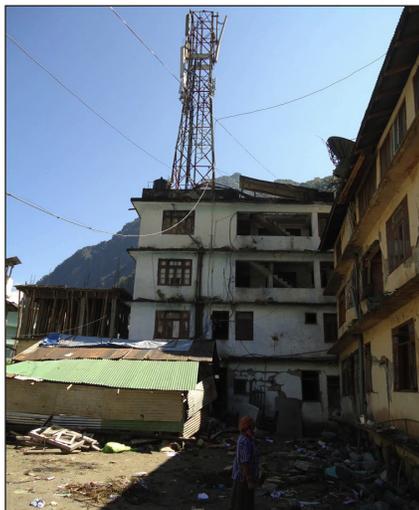
Communication systems failed in towns like Chungthan, Lachen, and Lachung after the earthquake shaking causing general power failures and/or severe damage to RC buildings with communication towers on their roofs (Figure 26). Telephone connectivity had not been restored even a month after the earthquake in North Sikkim.

Figure 26. Damage in lower story of RC frame building with telecom tower on its roof at Chungthang (photo: Arun Menon).

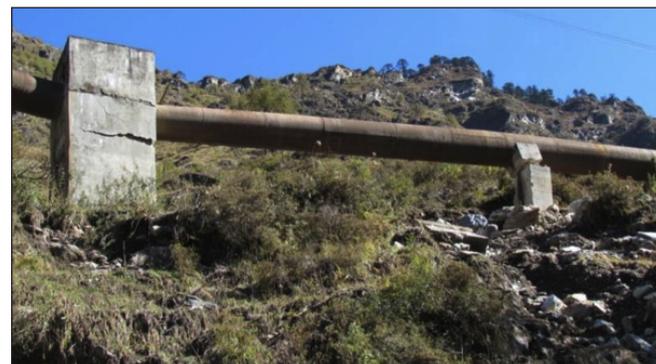
Dams and water structures. Water networks were damaged from sources to treatment plants, and from treatment plants to distribution nodes. The city of Gangtok lost its water supply due to landslide damage to the distribution network. In Lachen and Lachung, the water pipes bringing spring waters were damaged due to failure of concrete or rubble masonry pipe supports (Figure 27). The supports of water penstocks from mountain springs at Lachung are made of plain concrete; these penstocks were damaged due to landslides and rock falls.

Figure 27. Damage to plain concrete pipe supports of penstocks carrying water to town of Lachung (photo: Alpa Sheth).

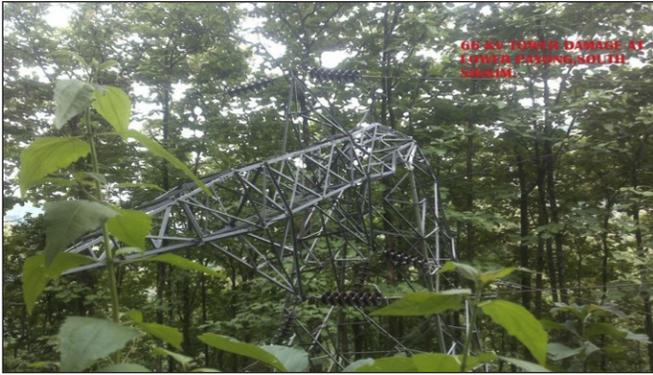
Electrical power. The meiseoseismal area lost power immediately after the earthquake due to collapse of high tension towers along the distribution network due to landslides (Figure 28). This also resulted in loss of landline and mobile communications in the affected area. High-tension towers and lines were damaged due to falling debris from landslides, and even local distribution poles were dislodged due to ground deformation generated by soft soil slopes. Power was not restored in worst-hit locations even 12 days after the earthquake.

Figure 28. Damage to electrical power transmission tower at Lower Payong, South Sikkim (photo: Government of Sikkim).
