Learning from Earthquakes

The M_w 6.9 Sikkim-Nepal Border Earthquake of September 18, 2011

This report is edited by C.V.R. Murty and Alpa Sheth.

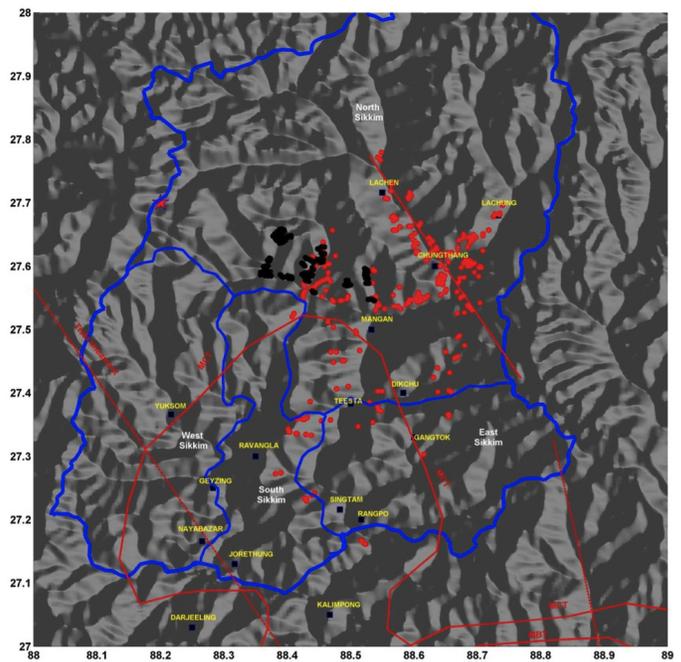
While landslides are frequent in this region during rainy seasons, an estimated 354 new landslides were caused by the event and 48 old ones reactivated (Figure 6). These slides damaged roads and bridges and disrupted relief operations to towns and villages that were completely cut off, some for over three weeks (Figure 7). Subsidence at Ranipool near Gangtok resulted in 180 mm settlement of a part of the National Highway, slowing vehicle movement and causing traffic jams.

Figure 6. Landslides in Sikkim during the main event; red dots indicate those mapped by National Remote Sensing Centre (India), black dots by NASA satellite image, and star the epicenter (source: STG Raghukanth).

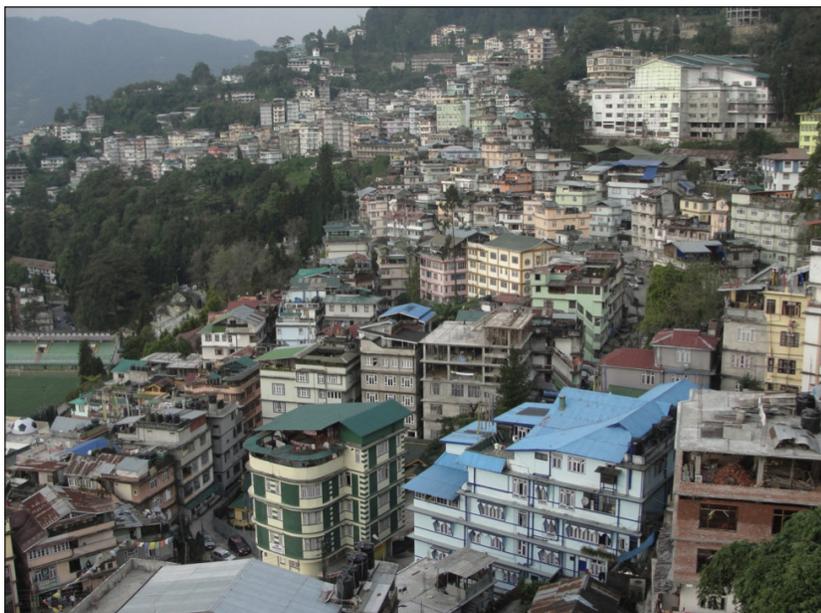
public domain) prepared by the Department from time to time. The current map divides the city into six categories on the basis of lithology, hill slope, seismicity and other aspects. A maximum of 5½ stories may be built in Zone 1, 4½ stories in Zone 2, and so on, with no construction allowed in Zone 6. UDHD regulations prohibit construction on slopes exceeding 70 degrees (but see Figure 11).

Figure 11. Dense unregulated RC construction on slopes in Gangtok city (photo: C.V.R. Murty).

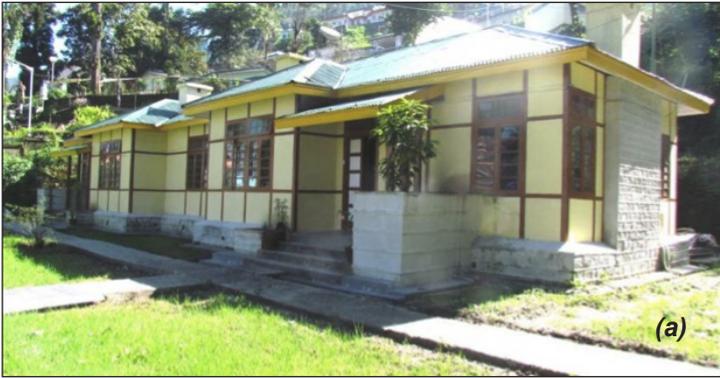
matting infill wall panels, and a light roof. The matting is plastered on both sides with mud or mud with fine river sand in earlier times, and by cement mortar in recent times. Another variation to this is the use of wood planks in construction by the rich. When made on flat ground, it rests on a relatively shallow and uniform masonry plinth (made of stone and mud mortar), and when made along hill slopes, it rests on a tapered stone plinth. Four varieties of stone masonry plinths are observed in Sikkim and the hills of Darjeeling: random rubble masonry (RRM) with and without mud mortar; dry dressed stone masonry; dressed stone masonry; and dressed stone masonry with pointing. In recent times, the plinth has been constructed with RC. During the earthquake, this type of housing was shaken to varying degrees, but with the exception of distress in some plinths (especially those made of RRM without any mortar), the houses performed exceptionally well. In instances where the cross-woven wood matting was replaced by clay-brick masonry in cement mortar, damage was sustained in the masonry infill walls, including out of plane collapse (Figure 12a and b).

Figure 12. ▲ (a) Typical ekra house at Gangtok (photo: Alpa Sheth); ► (b) Typical house with wooden planks (Shee Khim) with damaged rubble masonry plinth (photo: AR Vijayanarayanan).
